GREEN LAKE COMMUNITY CENTER AND EVANS POOL FACILITY ASSESSMENT

December 2008

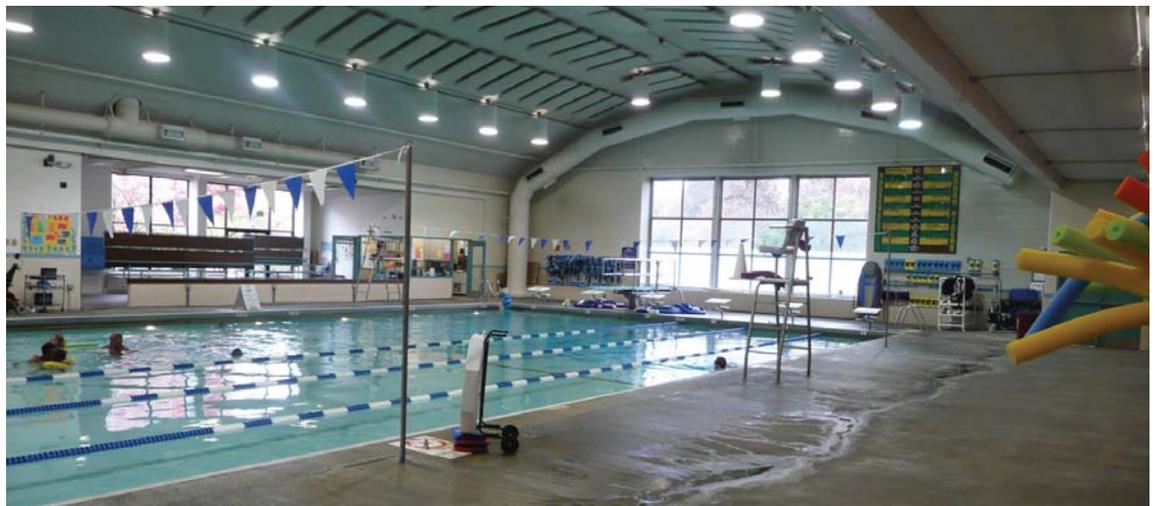
Figure 2 - Evans Pool with north and west windows

1. The windows on the west side of the pool, facing the entry garden have cracked seals and are leaking. The windows need to be replaced with thermally insulated units which will save on energy costs and improve user comfort.

Replace windows at the west side of the pool.

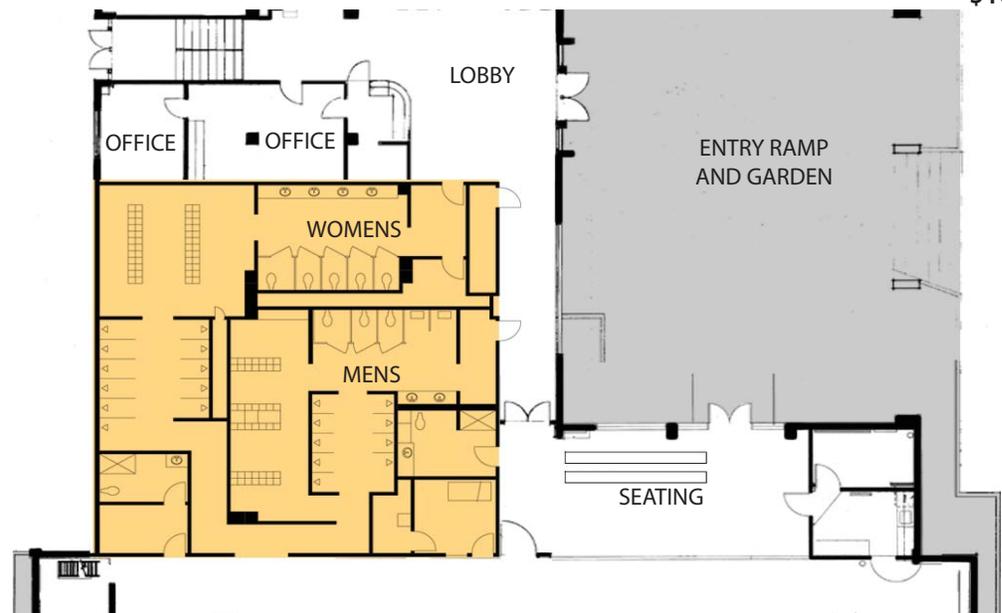
Figure 8 - New pool locker room and shower layout concept

- The pool has restrooms, locker rooms, and showers that are accessed from both the lobby and from the pool. These spaces have some new finishes but are poorly configured, have poor drainage, and cannot handle the number of users. The renovation of the swimming pool locker and restrooms should be combined with the recommended seismic improvements to provide a complete renovation of this area. See figure 8 for concept sketch.

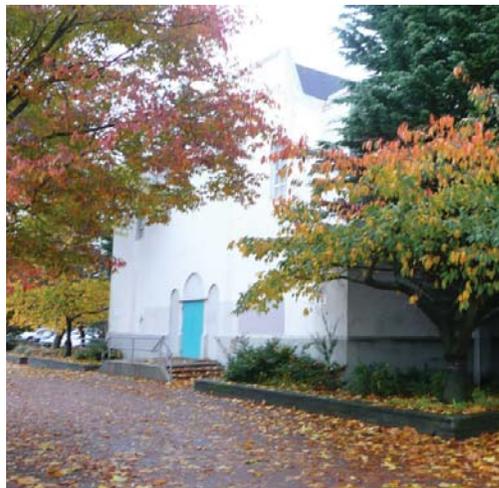
Figure 9 - Trees in front of building facing Greenlake

3. As shown in Figure 9, the gymnasium is hidden behind evergreen trees that grow very close to the foundations on the north and south sides. We recommend replacing these trees with new trees planted further from the building. The community center needs to be painted and could be creatively painted to bring some of the 1928 period character to these façades. Parks could develop an exterior color scheme and signage for the building. This would create a more visible and inviting gesture to the lake front users.

Replace evergreen trees, paint exterior, and add signage.

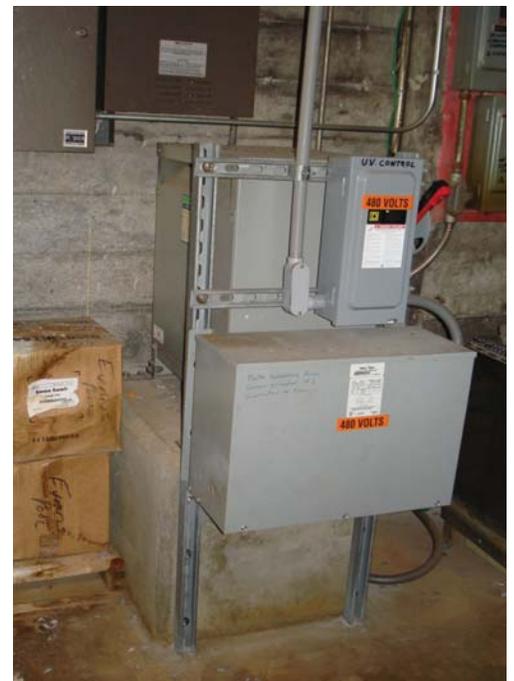
Figure 12 - Existing transformer in the basement

The facility is served by a 120/240V, 3 phase, 4 wire, 1000 amp Main Service Switchboard. The electrical panels are at 98% capacity and are in marginal condition due to age. Water comes into the basement where electrical equipment is located and corrosion is present at existing panels in this area. The panels in the basement are in poor condition. Mechanical equipment near the Main Service Switchboard encroaches on the code required clearance area in front of the switchboard. The transformer in the basement was observed to be generating excessive heat.

2. Replace transformer in the basement as it is in poor condition. Corrosion was observed due to water damage and it was noted that the transformer was producing excessive heat. A power shutdown of the feeder to the transformer will be required to replace it. Replacement should be done as soon as possible.

Replace transformer in basement.

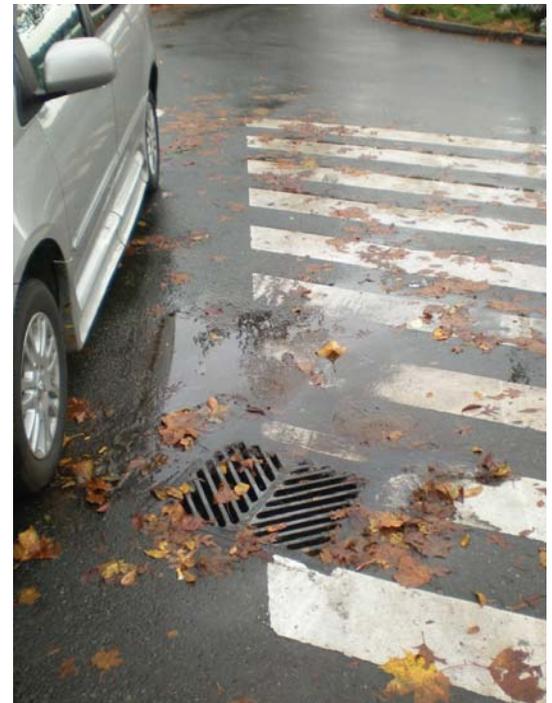
Figure 13 - Catch basin in ADA walkway.

Replace catch basin grate.

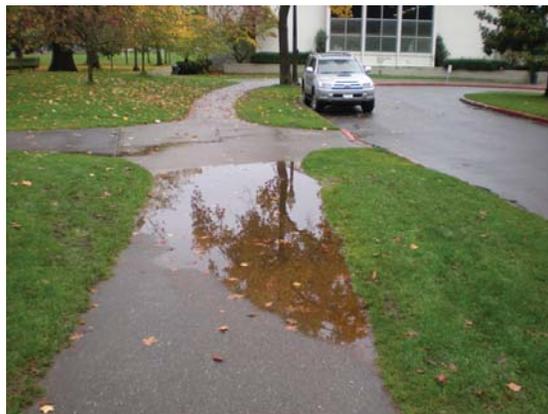
Figure 14 - Sidewalk with standing water

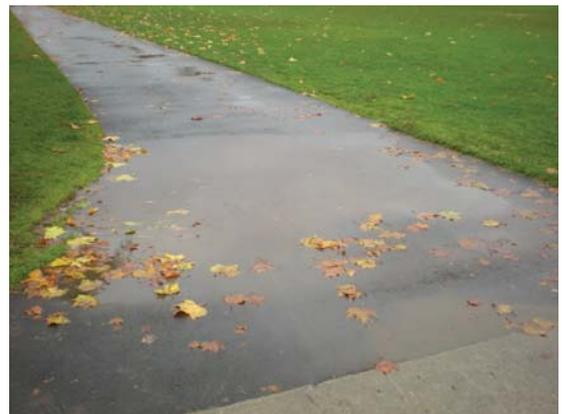
Figure 15 - Sidewalk with standing water
