Seattle Parks and Recreation

Community Centers Condition Assessment Screening

**March 8, 2008
Final**

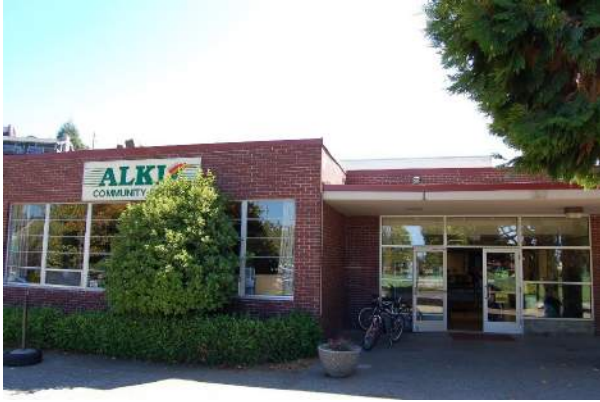
Name of Facility: Alki Community Center

Below is a summary of the building condition assessment done in 2007. The total assessment score was 72 out of 100. The main issues with the center are the roof (signs of leaks), heating, plumbing/sewage system, and the age of the facility and its finishes and furnishings showing signs of its age.

Building Element	Score	Comment
Foundation	10 out of 10	Concrete.
Exterior Walls	10 out of 10	Brick. Some tuckpointing on the south side is needed.
Windows/Doors	5 out of 10	Metal. Most are designed to be inoperable.
Exterior Gutters/Trim	5 out of 5	Metal.
Site	5 out of 5	Landscaping near the building is minimal, but nice.
Roof	1 out of 10	Leaks in the northwest corner of the building (preschool roof side).
Interior Floors	1 out of 2	Carpet, wood, tiles.
Walls/Ceiling	3 out of 5	Wall damage in northeast office.
Lighting	5 out of 5	
Restrooms	3 out of 5	Old ones need work. There is a family restroom that is fairly new and in good condition. No drain in the men's restroom, making it hard to clean.
Misc. Equipment	2 out of 3	
Emergency Regulations	5 out of 5	No security system.
ADA	5 out of 5	
Electrical	10 out of 10	
Heating	5 out of 5	
Plumbing	1 out of 5	Poor. Sewage backups 5-6 times per year in restrooms, kitchen, and storage areas. Sewage line to the east/northeast is blocked has a tree root intrusion problem.

- Heating system separation from the school
- Plumbing and sewer repair/replacement
- Roof repair or replacement

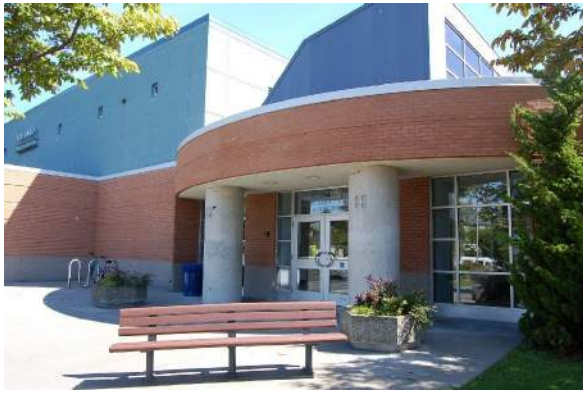
Name of Facility: Ballard Community Center

Below is a summary of the building condition assessment done in 2007. The total assessment score was 82 out of 100. The main issues are related to aging facilities: roof, furnishing renovation, wood flooring that can't be sanded, and need for door hardware that is beyond repair.

Building Element	Score	Comment
Foundation	10 out of 10	CMU/concrete.
Exterior Walls	5 out of 10	Brick, foam/fiberglass board, metal. Leaking.
Windows/Doors	10 out of 10	Metal. The interior door locks (one piece mechanism) problematic.
Exterior Gutters/Trim	5 out of 5	Metal.
Site	3 out of 5	Some new landscaping on the west side. Nice perennial garden on the south side. Lighting is not completely effective.
Roof	1 out of 10	Leaks in building. (Toddler/play room, kids room, gym #1)
Interior Floors	2 out of 2	Floor tile in the building needs sealing.
Walls/Ceiling	3 out of 5	
Lighting	5 out of 5	
Restrooms	5 out of 5	
Misc. Equipment	3 out of 3	
Emergency Regulations	5 out of 5	
ADA	5 out of 5	
Electrical	10 out of 10	
Heating	5 out of 5	
Plumbing	5 out of 5	
Other Issues		<ul style="list-style-type: none"> • Need fire door-magnetic door closers for the kitchen, Captain Ballard, and Sunset rooms. Electrical hookup issue. Ventilation is poor; often hot and stuffy. • The partition in the multi-purpose room doesn't always work.

- Replace roof.
- Furnishings renovation.
- Wood flooring in Multi-purpose rooms can't be sanded and will eventually have to be replaced.
- Door hardware replacement
- Long term interest in an addition on the northeast corner of the building for additional storage.

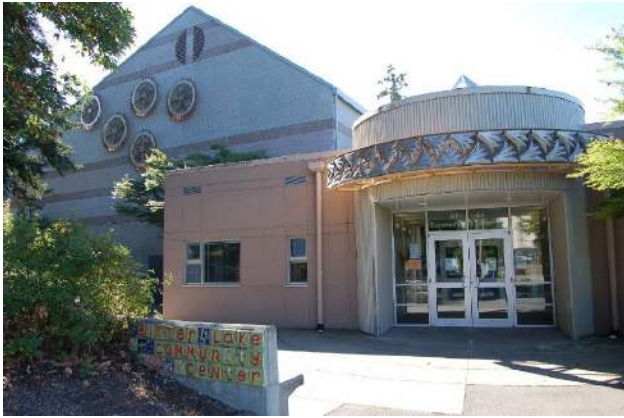
Below is a summary of the building condition assessment done in 2007. The total assessment score was 90 out of 100. The main capital issue is that the windows may need to be replaced or repaired due to water intrusion and faulty sealants. Some of the windows and doors in the building do not close properly.

Building Element	Score	Comment
Foundation	10 out of 10	CMU/concrete.
Exterior Walls	10 out of 10	CMU/concrete/metal.
Windows/Doors	5 out of 10	Metal doors and windows. The south door interior locking bar jams and doesn't always close (security issue). The windows in the multi-purpose room, north side, don't shut properly and possible faulty sealant issue. West side windows have water intrusion.
Exterior Gutters/Trim	5 out of 5	
Site	5 out of 5	
Roof	10 out of 10	
Interior Floors	2 out of 2	The tile in the teen and art rooms scratches easily, and it is hard to maintain.
Walls/Ceiling	5 out of 5	Some cracks in ceiling by the skylight. Moisture intrusion in one panel of the skylight.
Lighting	5 out of 5	
Restrooms	5 out of 5	
Misc. Equipment	3 out of 3	
Emergency Regulations	5 out of 5	
ADA	5 out of 5	
Electrical	5 out of 10	Breakers trip a lot, especially when the kitchen and multi-purpose room are in use (e.g., coffee pot will trip)

- HVAC duct cleaning
- Window replacement or repair.

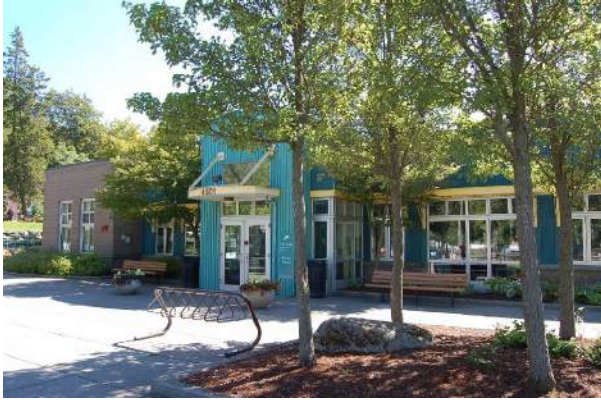
Name of Facility: Delridge Community Center

Below is a summary of the building condition assessment done in 2007. The total assessment score was 84 out of 100. Although the community center was new in 2000, the boiler needs to be replaced. The outside doors should be repaired.

Building Element	Score	Comment
Foundation	10 out of 10	
Exterior Walls	10 out of 10	Exterior recently resealed.
Windows/Doors	1 out of 10	The multi-purpose room and gym push doors-the hydraulics don't work. There are gaps in the gym doors, allowing wind and rain in the south end of the gym. Gym floors get wet during storms.
Exterior Gutters/Trim	5 out of 5	
Site	5 out of 5	More exterior, perimeter lighting is needed.
Roof	10 out of 10	
Interior Floors	2 out of 2	Some baseboards need repair; space between floors and baseboards.
Walls/Ceiling	5 out of 5	Old stains in ceiling in the weight room (plumbing leaks, not roof).
Lighting	5 out of 5	The lobby lighting is low.
Restrooms	5 out of 5	There is white grout in the men's restroom floor, which is hard to keep clean.
Misc. Equipment	3 out of 3	Need electrical work to hook up new clothes washer.
Emergency Regulations	5 out of 5	
ADA	5 out of 5	
Electrical	5 out of 10	Electrical is a moderate issue. The breakers trip in the MP room when coffee makers are turned on.

Heating	3 out of 5	The boiler leaks. Some hot and cold spots in the building.
Plumbing	5 out of 5	
Other Issues		There is a generator in the building.
TOTAL SCORE	84

- New boiler
- Exterior door repairs
- Room Dividers

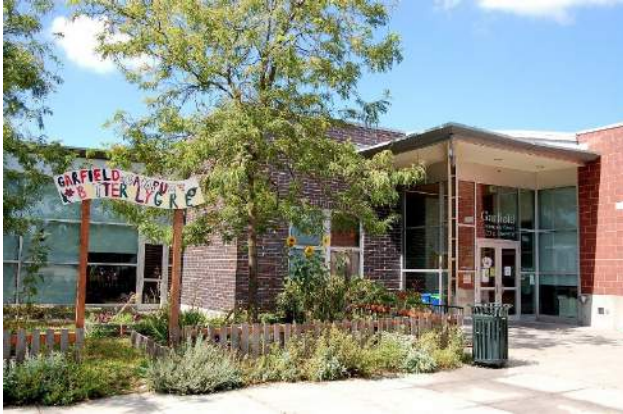
Name of Facility: Garfield Community Center

Below is a summary of the building condition assessment done in 2007. The total assessment score was 100 out of 100. The building has worn well. There is evidence of some leaks on the west side of the day care room and in the gym, but they appear to be work-order magnitude issues.

Building Element	Score	Comment
Foundation	10 out of 10	Concrete.
Exterior Walls	10 out of 10	Concrete, metal, CMU
Windows/Doors	10 out of 10	Metal. The southwest side has garage-type rollup doors.
Exterior Gutters/Trim	5 out of 5	
Site	5 out of 5	Landscaped. Inviting entry.
Roof	10 out of 10	(See note below. The score of 10 reflects lack of leaking, but the problem identified by Mark Orth is different.)
Interior Floors	2 out of 2	
Walls/Ceiling	5 out of 5	West side of Kidspace has leak evidence. The west and south side of the gym has some white spots-possible leaks. (Shops w/o.)
Lighting	5 out of 5	
Restrooms	5 out of 5	
Misc. Equipment	3 out of 3	
Emergency Regulations	5 out of 5	
ADA	5 out of 5	
Electrical	10 out of 10	
Heating	5 out of 5	
Plumbing	5 out of 5	
Other Issues		Very high ceilings in some rooms makes heating expensive.
TOTAL SCORE	100

Note: Mark Orth, a Civil Engineer in Parks, has identified a roofing defect that needs to be addressed.

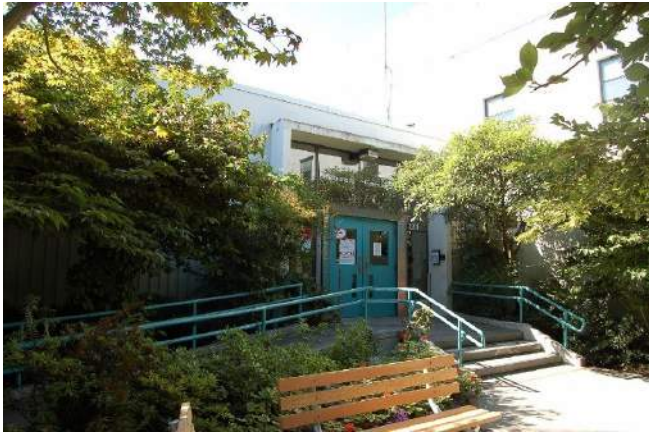
Name of Facility: Green Lake Community Center

Below is a summary of the building condition assessment done in 2007. The total assessment score was 38 out of 100, which is the lowest score for all community centers. The building needs building envelope renovation (roof, exterior, and foundation work), restroom renovations, ADA improvements, and cosmetic finish renovation.

Building Element	Score	Comment
Foundation	1 out of 10	Earthquake damage evidence at foundation.
Exterior Walls	5 out of 10	Peeling paint on stucco.
Windows/Doors	1 out of 10	Some warped exterior doors. Few windows, and only some of them open.
Exterior Gutters/Trim	3 out of 5	
Site	5 out of 5	Not enough exterior lighting on building, especially the unlit southwest plaza
Roof	1 out of 10	Roof leaks.
Interior Floors	0 out of 2	Flooring is unlevel in the game room/lobby. There is a differential in the floor between lobby and game room (earlier addition).
Walls/Ceiling	3 out of 5	
Lighting	3 out of 5	Gym lighting is low, and dark in the south end.
Restrooms	0 out of 5	The men's restroom lacks ventilation, has peeling paint, low lighting, the exterior doors need replacement, and the partitions need to be reduced in size for security. (This restroom has been remodeled since this assessment.)
Misc. Equipment	1 out of 3	Access to 2 nd floor a problem. Ex: taking tables from the gym to the second floor requires going outside.

- Architectural and Engineering Study
- New roof/seismic
- Structural/foundation shoring
- ADA improvements
- Cosmetic finishes renovation

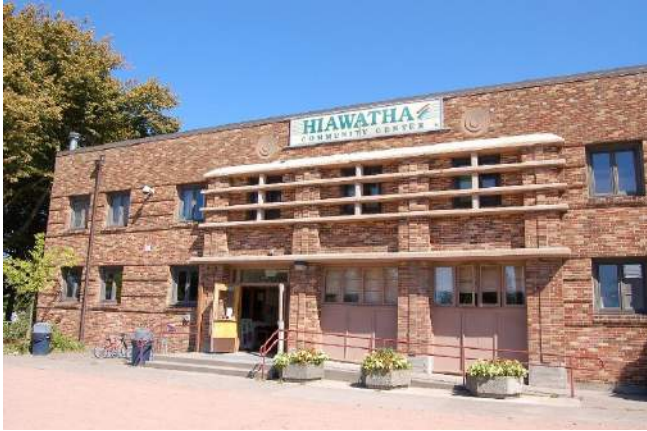
Below is a summary of the building condition assessment done in 2006. The total assessment score was 71 out of 100. There may be a settling issue south of the lobby area. There are some leaks in the multi-purpose room.

Building Element	Score	Comment
Foundation	5 out of 10	Concrete.
Exterior Walls	5 out of 10	Brick
Windows/Doors	5 out of 10	Metal windows. Windows not all properly installed (aesthetic issue).
Exterior Gutters/Trim	5 out of 5	
Site	5 out of 5	Landscaping near the building and on the site is excellent.
Roof	5 out of 10	There are leaks in the south multi-purpose room.
Interior Floors	0 out of 2	The dirt from the ballfield and track gets dragged into the building, causing it to wear. There is a settling issue, to the south of the lobby area.
Walls/Ceiling	3 out of 5	Some walls have cracks.
Lighting	1 out of 5	Need more lighting on the east side of the building for security. Also, some exterior lighting on the west side of the building is connected with the ballfield lighting, so both are on or off.
Restrooms	5 out of 5	
Misc. Equipment	2 out of 3	
Emergency Regulations	5 out of 5	
ADA	5 out of 5	
Electrical	5 out of 10

- Foundation assessment.
- Window assessment.
- Security lighting on the east side of the building.

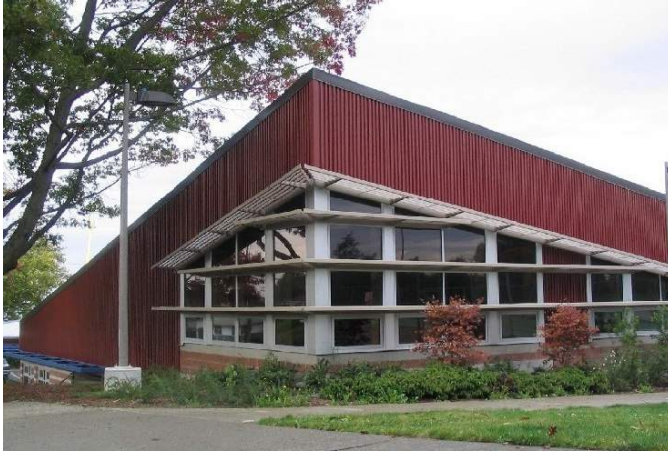
Name of Facility: High Point Community Center

Below is a summary of the building condition assessment done in 2007. The total assessment score was 90 out of 100. Since it was recently renovated, there are no major issues. Improving the ventilation in the lobby is suggested.

Building Element	Score	Comment
Foundation	10 out of 10	Cement.
Exterior Walls	5 out of 10	CMU/metal/stucco. There is a big gap in the north gym wall and in other parts of the walls (need caulking).
Windows/Doors	10 out of 10	Metal doors and windows. The south side door has leaks under the door (game room and child care). Access to the upper windows in the MP room is nearly impossible, even on a ladder (very hot in the summer).
Exterior Gutters/Trim	5 out of 5	
Site	5 out of 5	Some light don't work on the south side (light poles).
Roof	5 out of 10	Some signs of leaks in the child care room and mechanical room.
Interior Floors	2 out of 2	
Walls/Ceiling	5 out of 5	Need paint. Wainscoting or coating for wall in the multi-purpose room to prevent scuffing.
Lighting	5 out of 5	Can be dark in the lobby area, but there is good natural light in the rest of the building.
Restrooms	5 out of 5	The vent in the game room restroom is not working.

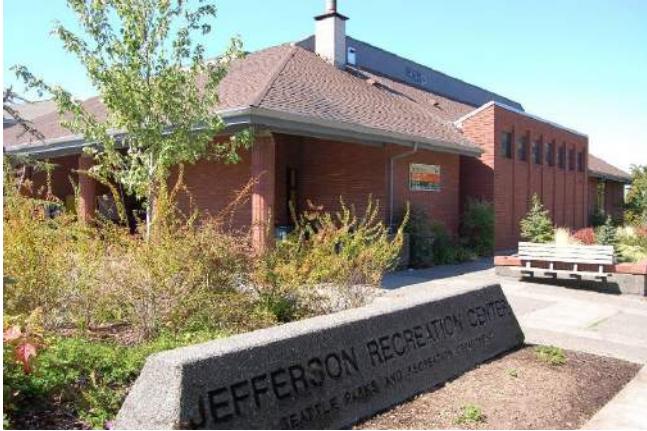
Below is a summary of the building condition assessment done in 2007. The total assessment score was 89 out of 100. The main issues are related to aging major systems: leaking skylights; the electrical system at capacity, and a boiler that will need to be replaced.

Building Element	Score	Comment
Foundation	5 out of 10	Concrete.
Exterior Walls	10 out of 10	Brick/wood/cement. Gym: CMU/plywood/metal.
Windows/Doors	5 out of 10	Metal.
Exterior Gutters/Trim	5 out of 5	
Site	5 out of 5	
Roof	10 out of 10	Skylights in art room leak.
Interior Floors	1 out of 2	Hallway floors buckling and cracking (5 years old). Flooding in winter storm power outage (sump pump couldn't operate for 8 days) affected south ½ of the gym floor.
Walls/Ceiling	5 out of 5	
Lighting	5 out of 5	
Restrooms	5 out of 5	
Misc. Equipment	3 out of 3	
Emergency Regulations	5 out of 5	
ADA	5 out of 5	Basement showers and restroom not ADA.
Electrical	5 out of 10	Need more outlets in the computer room. At capacity
Heating	5 out of 5	Boiler motor replaced in the winter.
Plumbing	5 out of 5	
Other Issues		<ul style="list-style-type: none">• Storage needed in the gym• Gas kiln will need replacement.• Need window coverings in the north room (rental)• Remodeling possibilities for more functional space.

- Remodel multiple rooms to better accommodate today's needs
- Electrical
- New boiler
- Gas kiln replacement
