GREEN LAKE COMMUNITY CENTER AND EVANS POOL FACILITY ASSESSMENT

December 2008

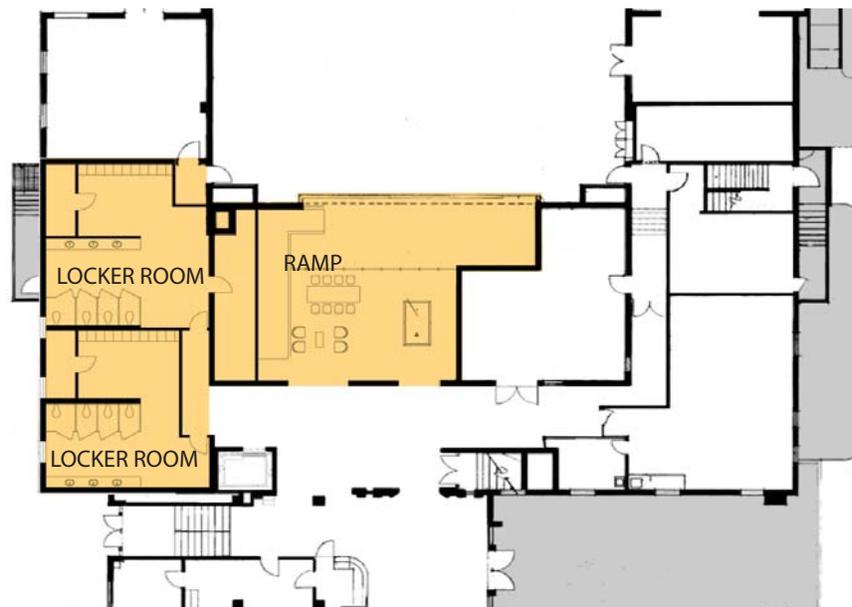
Figure 7 - New restrooms, locker rooms, and ramp to gymnasium layout concept

1. Access to the gymnasium from the lobby is located down a hall, around the corner, down five steps, past women's showers, and through a single door. The gymnasium needs to be accessible from the lobby and visible for staff oversight. A ramp and windows could be installed in place of the existing stage. (See Figure 7)

4. By providing a new separate comfort station, the community center restrooms can be reconfigured to provide ADA code compliant restrooms that are accessed directly from the main lobby. New men's and women's restrooms and locker rooms can be built just south of the lobby with obscure windows to the south providing great daylighting. Each locker room could include a lockable shower or more storage space for visitors. The community center could also reconfigure the existing women's restroom on the north side for more gymnasium storage and expansion of the pottery room spaces. See Figure 7 concept sketch.

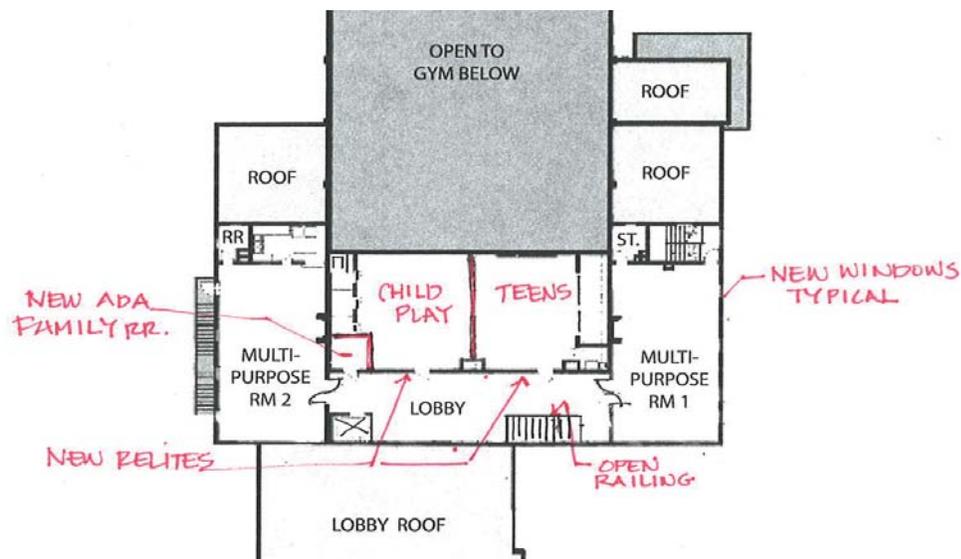
Figure 11 - Second floor renovation concept layout

- The second floor open child play room is very generous and well used. Parks could consider dividing this space into two spaces, one for toddlers and one for teenagers. Both spaces should have relites to the hallway for visibility and to gain natural daylight from the windows across the hallway. It would be beneficial for all of the meeting spaces at the second floor to add an ADA family restroom across from the elevator. Renovation of the second floor should also include removing the walls around the stair since it does not need to be enclosed. This would open up the connection between the two lobby spaces. See Figure 11.

Renovate the second floor including restroom, relites, and railings.
