**Friends of Green Lake
Green Lake
“To Do” List
July 20, 2016**

**Friends of Green Lake's
Green Lake
"To Do" List
July 20, 2016**

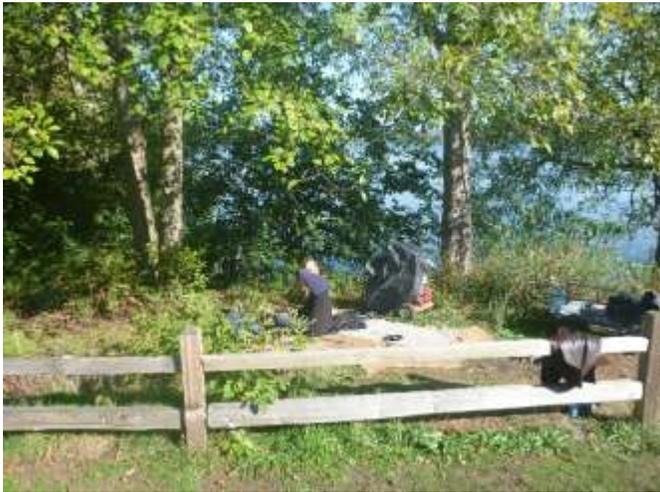
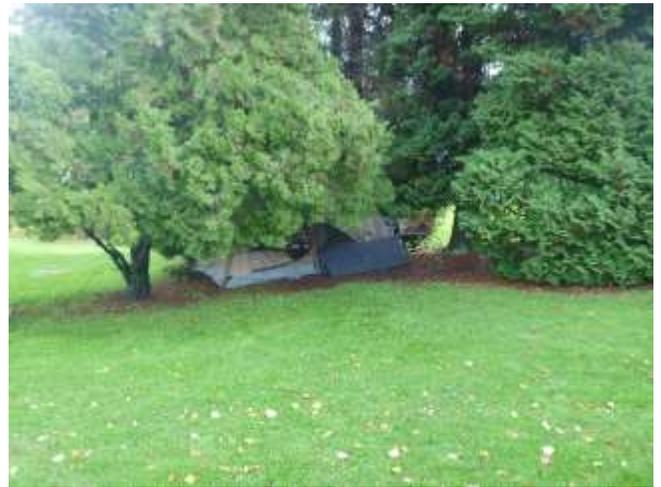
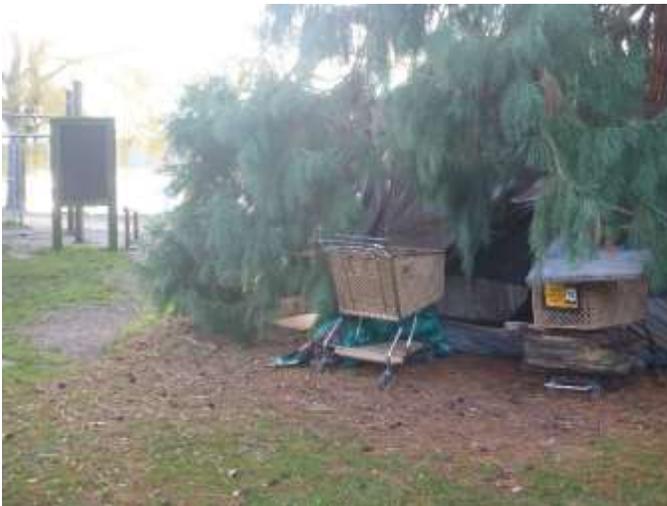
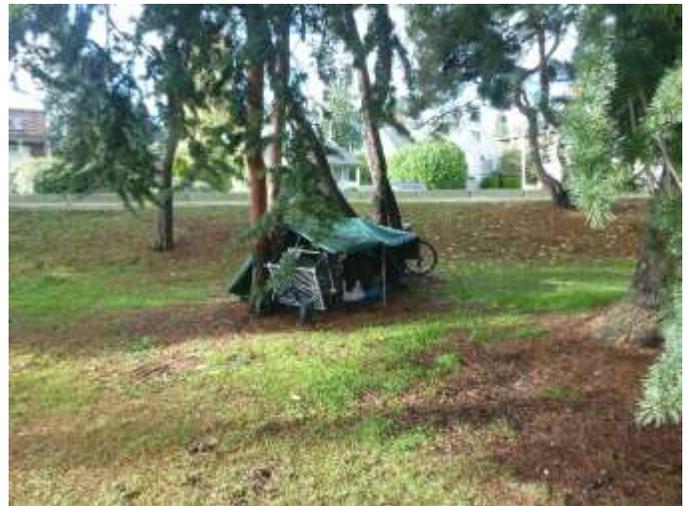
Camping in a vegetation island

Camping near the wading pool

Camping near boat rental (with tapped in electricity)

Camping next to Aurora Avenue

Problem: There is a growing use by the homeless of the park for overnight camping. This is inappropriate, given the degree of use of the park by families with small children and often unsupervised use of the park by older children using skateboards, playing soccer, jogging, or participating in activities at the Small Craft Center. Refuse and human waste are often found scattered around camp sites.

Recommended Action: If there is to be camping at Green Lake Park, the Superintendent should publicly state the Department’s objectives, establish necessary policies, determine appropriate camping sites including location, management programs and support facilities such as toilets and fireplace sites. His intentions should be published and presented at public meetings.

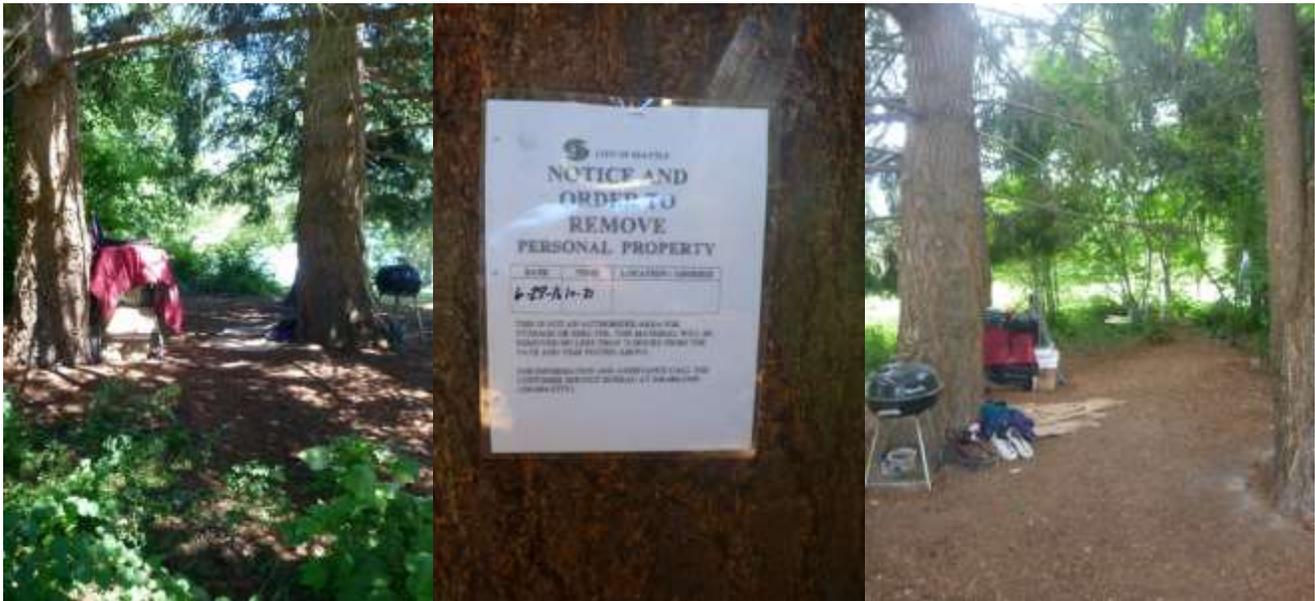
A recurring camp site in a fenced Natural Habitat Island south of the Bathhouse Theater

The current policy regarding camping in Green Lake Park seems to be to ‘keep them moving’ but not out of the Park. The notice pictured above orders the removal of personal property and does not address the camping violation. The pictures above documents that habitat destruction is taking place in a fenced natural habitat area. SDPR should document the extent of camping in Green Lake Park and propose measures to bring such activities within the constraints of the Seattle Municipal Code.

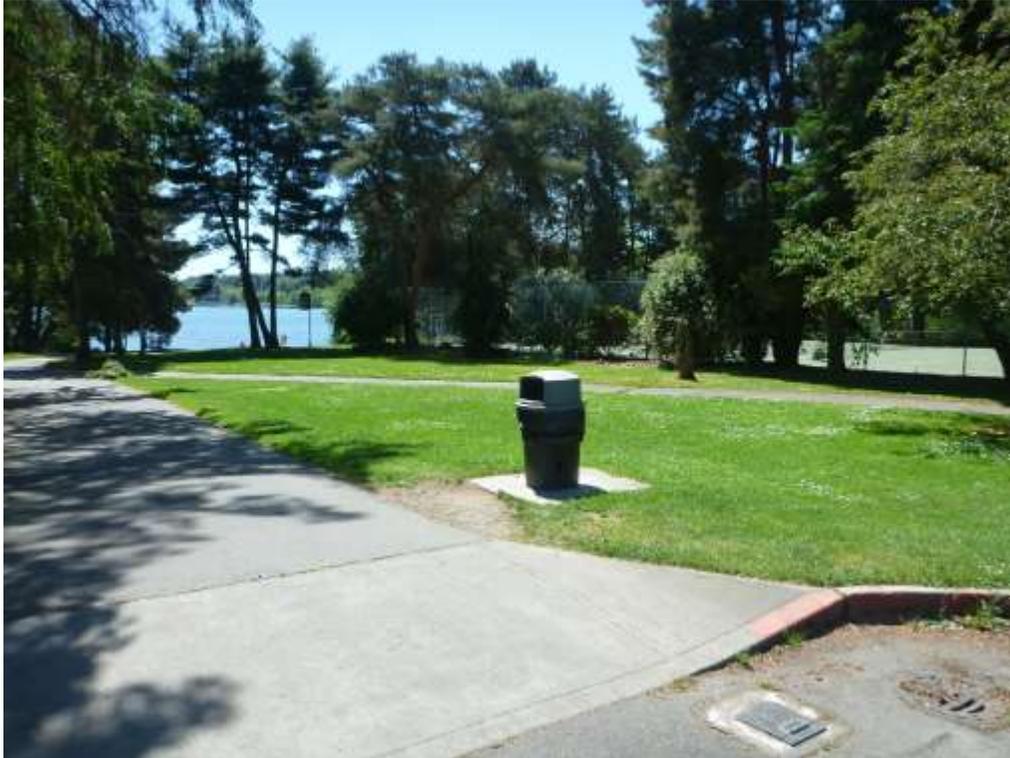
Path from Bathhouse Parking Lot to the Green Lake Path; tennis courts on the right.

Problem: Currently, restrooms in the West Beach Changing Rooms in the Bathhouse Building are available only when the West Swimming Beach is in operation and when Life Guards are present (from June 25th to September 6th from 11:00AM to 7:00PM).

Recommended Action: Construct small restroom open year around.

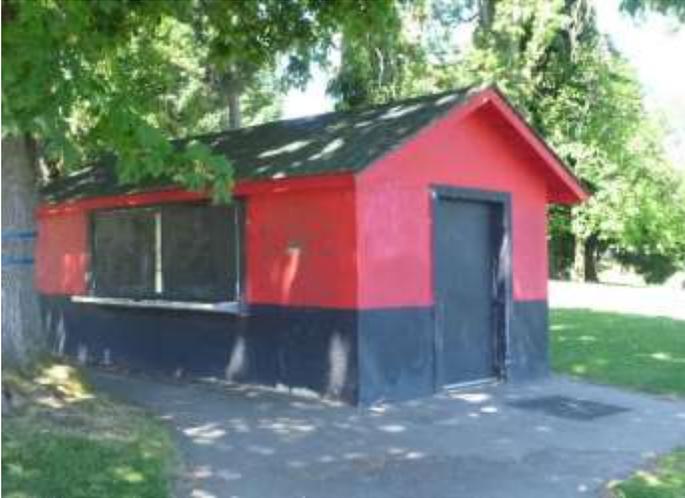
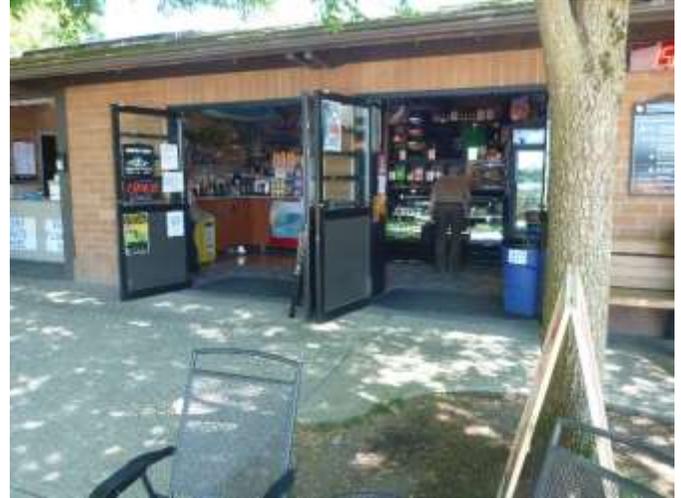
1. Food Service at West Beach

2. Food Service at East Beach

Problem: Food service at East Beach does not have either water or sewer services. The food service at West Beach had water and sewer service recently installed.

Recommended Action: Install water and sewer services at East Beach.

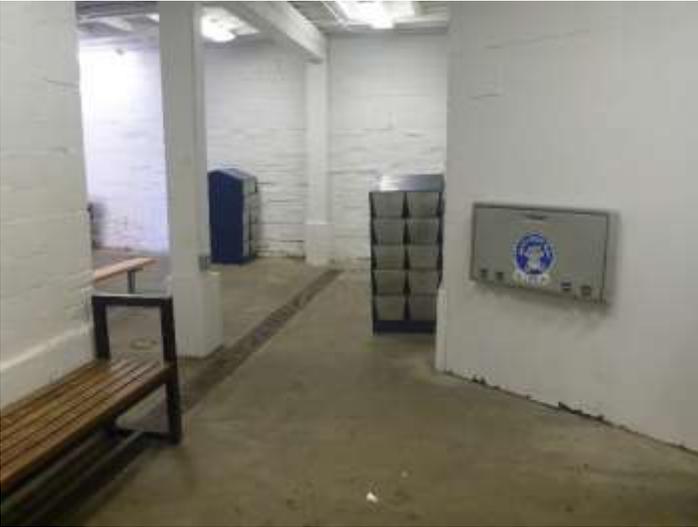
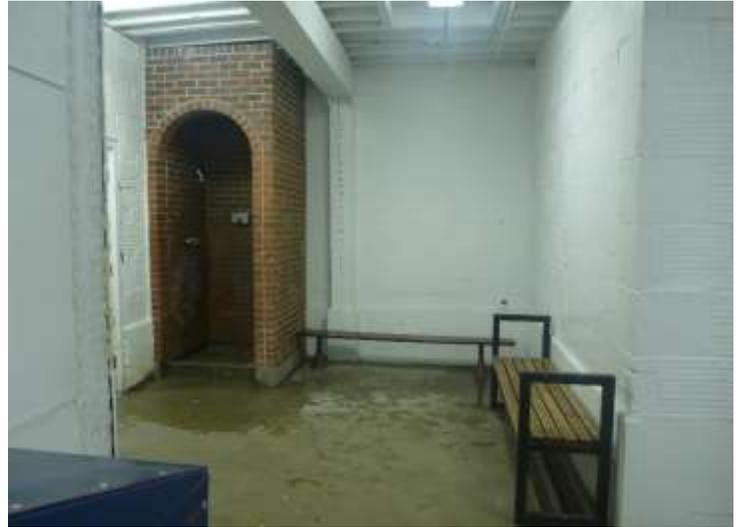
Changing Room West Beach (Bathhouse)

Men's Shower, West Beach (Bathhouse)

Problem: The Bathhouse building was constructed in 1927. Sometime later the central portion of the building was converted into a small theater and now is operated as the Seattle Public Theater at the Bathhouse. Separate from the Seattle Public Theater, the building includes changing rooms with toilets and showers for the West Beach swimming area. The arrangement of the changing rooms, bathrooms, plumbing and lighting fixtures have received little more than maintenance over the last 60 years.

Discussion: The changing rooms for swimmers at West Beach are sadly out of date and do not meet current expectations for such facilities. The changing rooms at West Beach have recently been cleaned up, painted and have new lighting. Conditions are much improved but the need for an upgrade remains. A substantial remodel will be required to update these facilities. Properly reconfigured, the bathrooms in the changing rooms could be opened year- round, which would preclude the need for another bathroom facility on the west side of the lake.)

Recommended Action: Develop and implement an upgrade of the Bathhouse facilities.

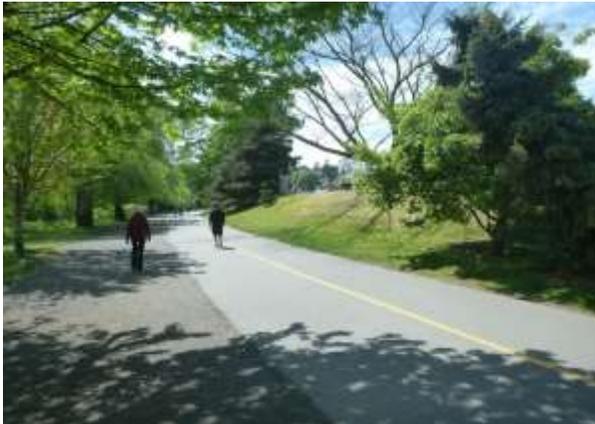
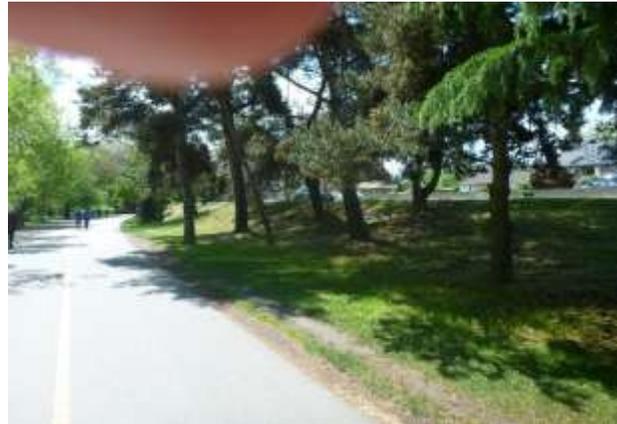
Gap in the trees bordering Aurora Ave. Trees between Aurora Ave. & Green Lake Path

Problem: There is no shoulder for the northbound lanes on Aurora Avenue (State Route 99) as they runs adjacent to Green Lake Park. When an out of control vehicle departs the northbound lane it crosses a narrow planted strip before reaching the Green Lake Path. To date, vehicles departing Highway 99 have been stopped by small trees and shrubs in the planted strip. There are gaps in the planted strip.

Recommended Action: Plant well-spaced trees and larger shrubs in the existing gaps. An alternative would be for the State Department of Transportation to place Jersey Barriers along the curb.

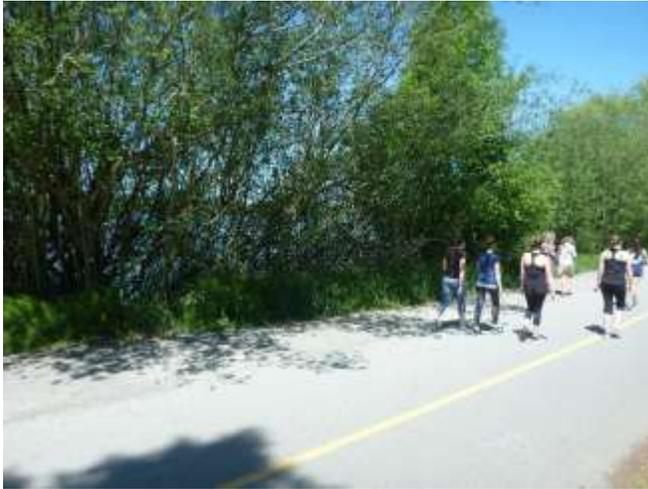
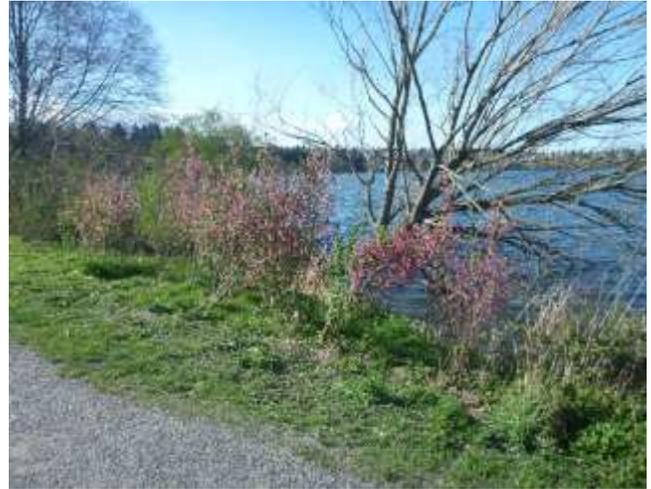
Recent growth of alder and willow

Restoration site replanted in 2010

Problem: The existing Landscape Management Plan was prepared in 1995 (no date on the Plan provided on-line). The Plan does not reflect either current conditions or current intentions.

Recommended Action: Prepare a Shoreline Vegetation Management Plan for the shoreline planting (from the Green Lake Path to the shoreline). The plan should describe goals and objectives, assign responsibility for implementing and maintaining the plan, and provide sufficient detail to guide maintenance of the plantings along the shore. The Plan must conform to the special regulatory requirements in riparian areas. The Shoreline Vegetation Management Plan is identified as a Capital Project because it will require either substantial staff time or contracting with Landscape Planners for its preparation.

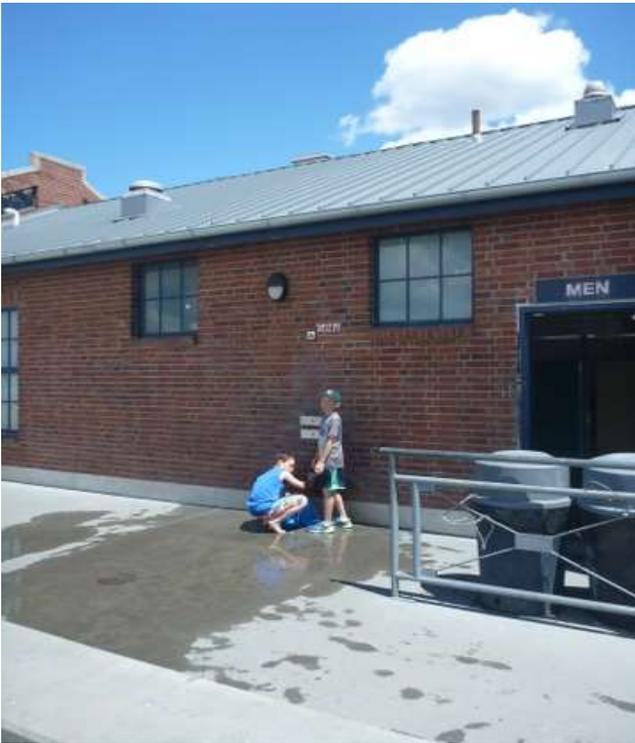
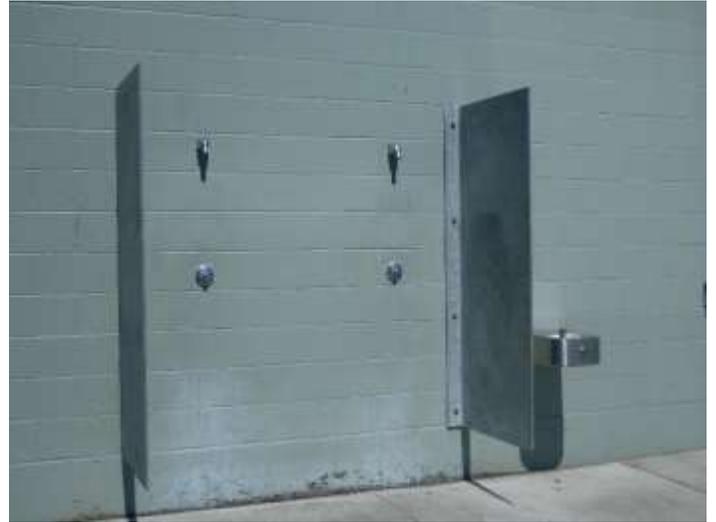
II-f. Provide Exterior Rinse-Off Showers at East and West Beach

Rinse-Off Shower at Golden Gardens

Rinse-Off Showers at Magnusen Park

Location: West and East Beaches at Green Lake.

Problem: Public Information signs along Green Lake Path recommend rinsing-off when coming out of the water. This recommendation is especially important when algal scums or swimmer's itch are present at Green Lake. At the present time, rinse-off showers are available in the changing rooms at East and West Beach only when the changing/bathrooms are open. Times vary during the year for each facility. There are no other showers along the Green Lake Path.

Recommend Action: Install exterior rinse-off showers at East and West Beach Swimming Areas, and at the Wading Pool.

Discussion: Showers are available to lake users only when Life Guards are present at West Beach and only when the Community Center is open at East Beach. Exterior rinse-off showers should be available for lake users when these facilities are not open.

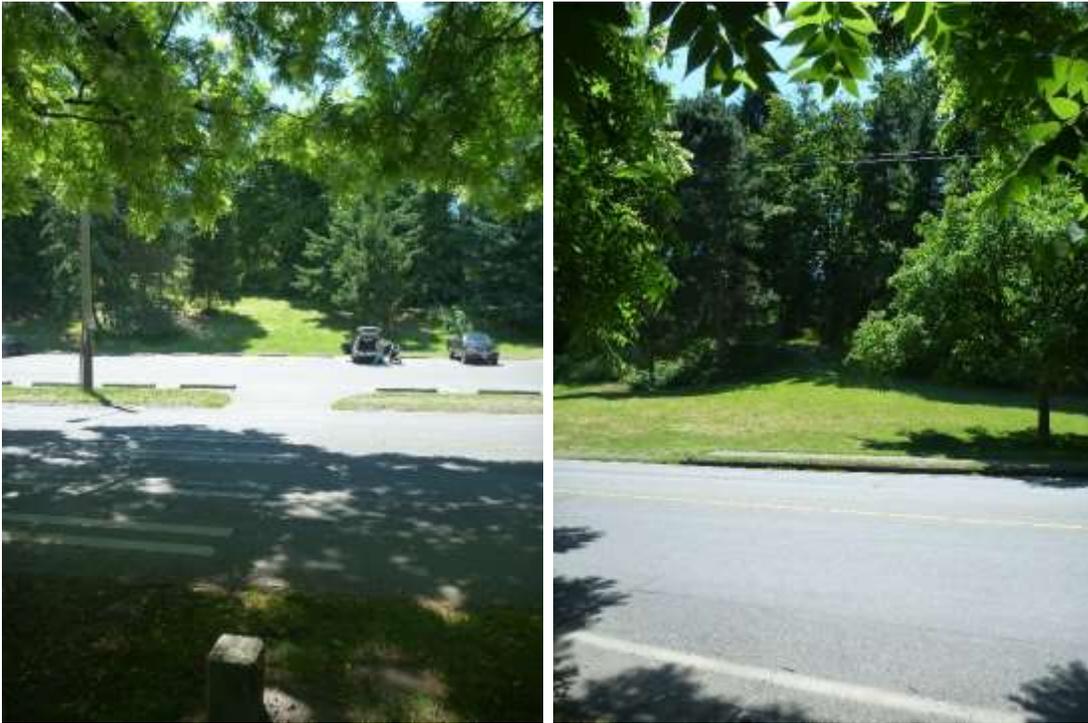
II-g. Paved Path Linking the Green Lake Path to Upper Woodland Park

Two possible alignments linking the Green Lake Path to Upper Woodland Park

Location: West Green Lake Way N. separates southern border of Green Lake Park from upper Woodland Park.

Recommended Action: Develop a paved path connecting the two parks. An inviting path and direction/informational signs would connect the two parks.

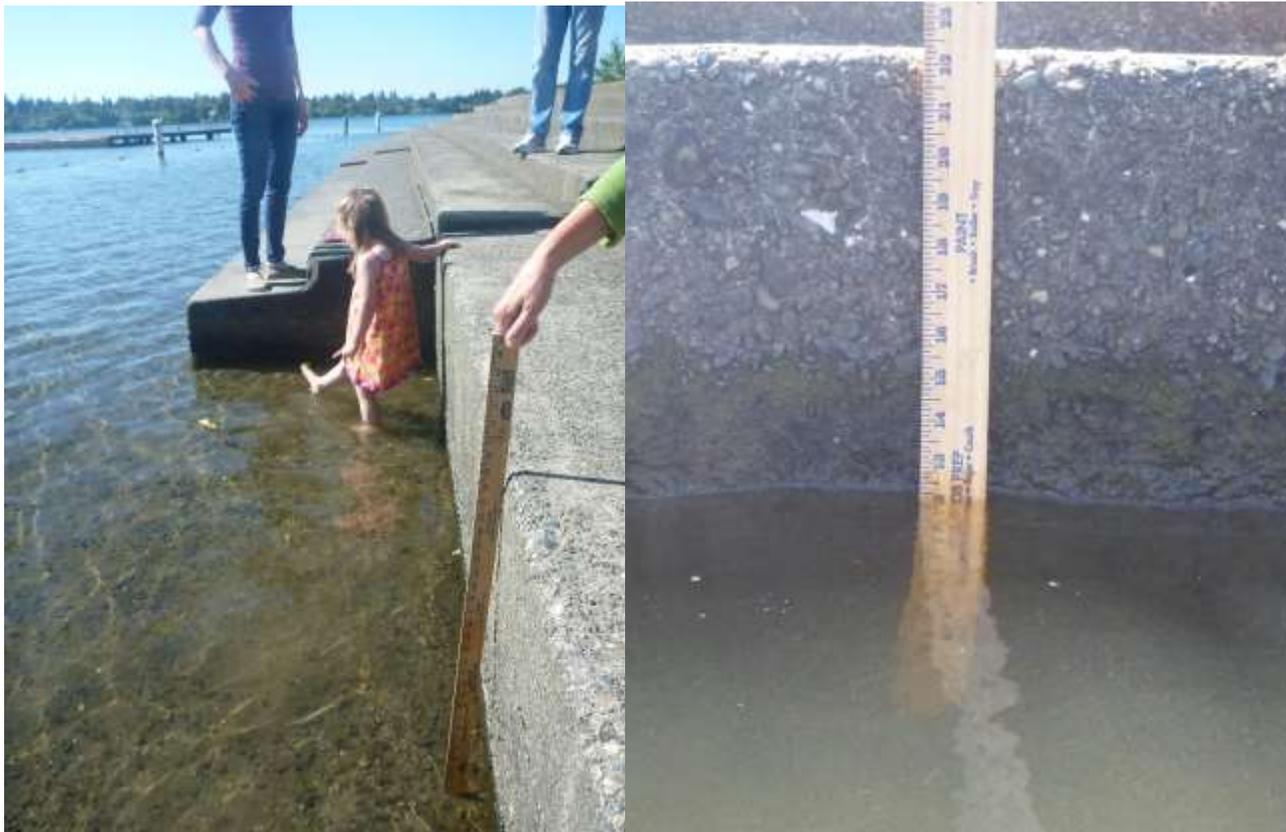
Steps into Water at West Beach. From the sandy bottom to the top of the first step is 22 inches. The top of the bulkhead in the foreground is 27 ½ inches.

Problem: The last step into the water has a rise of 22 inches. This makes access into and egress from the water difficult for small children and persons with mobility problems. The Seattle Building Code specifies steps with a rise of 7 inches (and no more than 7 ¾ inches) and a run of 11 inches (and no less than 10 inches).

Recommended Action: Install additional steps into the water.

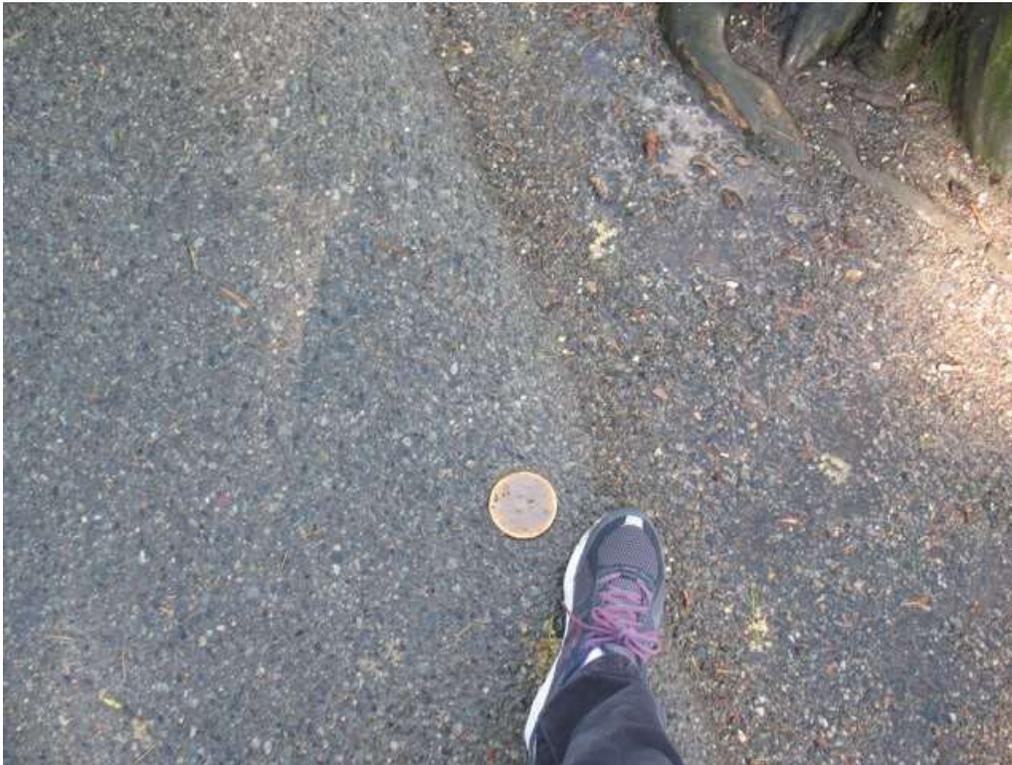
III-a. Install Numbered Trail Markers on the Green Lake Path

Trail Marker on the Green Lake Path

Location: Green Lake Path

Recommended Action: Install Numbered Trail Markers on the Green Lake Path. The distance from a prime location (the Community Center) would be stenciled onto the pavement every 0.1 mile clockwise around the circuit of the Path. If successful, the stenciled markers could eventually be replaced by brass markers. This has been included as a Maintenance Issue because implementation should not require substantial costs. A digital map of location markers would be provided to Park Users and to emergency responders. A poster board would also provide a map of the markers around the lake and their uses.

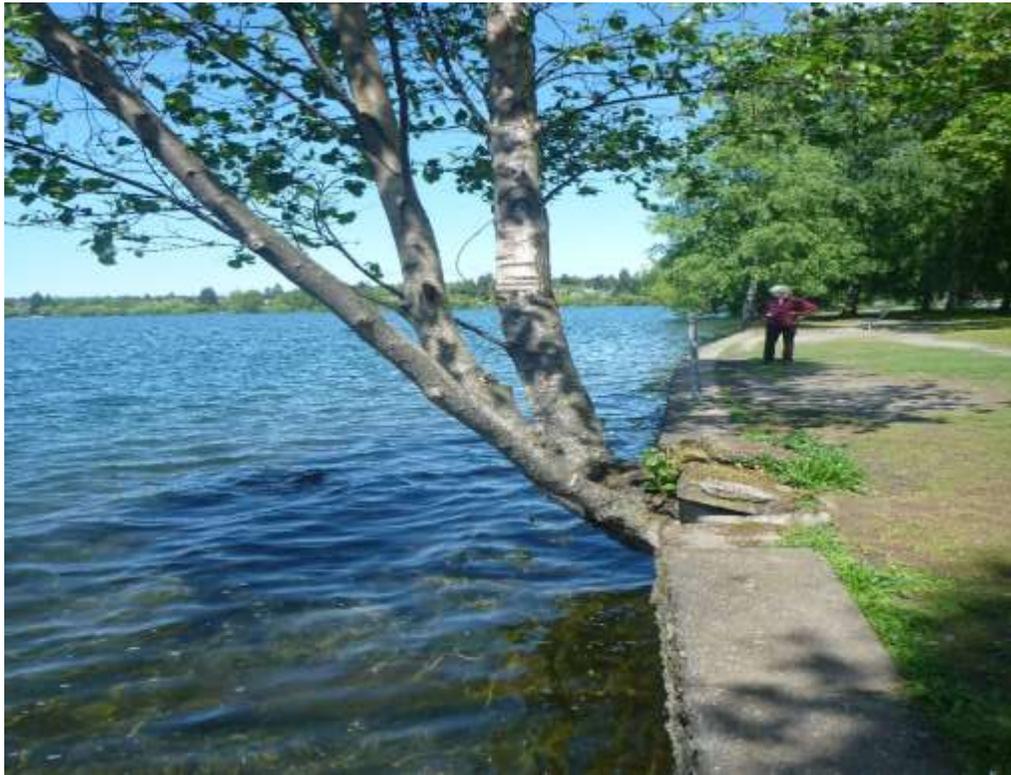
Alder tree growing between blocks of the shoreline wall on east shoreline.

Problem: Trees and shrubs growing between blocks of the shoreline wall disrupt the structure of the wall and can lead to the wall's collapse.

Discussion: At many places along the wall, “volunteer” trees and shrubs have started growing between the blocks of the shoreline wall. Ultimately, these shrubs and trees can disrupt the structure of the wall. A failure of the wall in 2015, near the 66th Street outlet, resulted in substantial cost to the department including filing for an Hydraulic Permit from the Washington State Department of Ecology, repairing the wall and, as a condition of the Permit, designing and installing a mitigation site near the Wading Pool.

Recommended Action: Volunteers prune seedlings, saplings and shrubs less than 2 inches in diameter growing between the blocks of the shoreline wall. SDPR remove saplings, shrubs and all trees over 2 inches in diameter and remove cut wood from the shoreline. Remove and reset paving blocks as necessary. Parks should develop a plan for inspection of the shoreline wall and maintenance options, and assign responsibility for these activities.

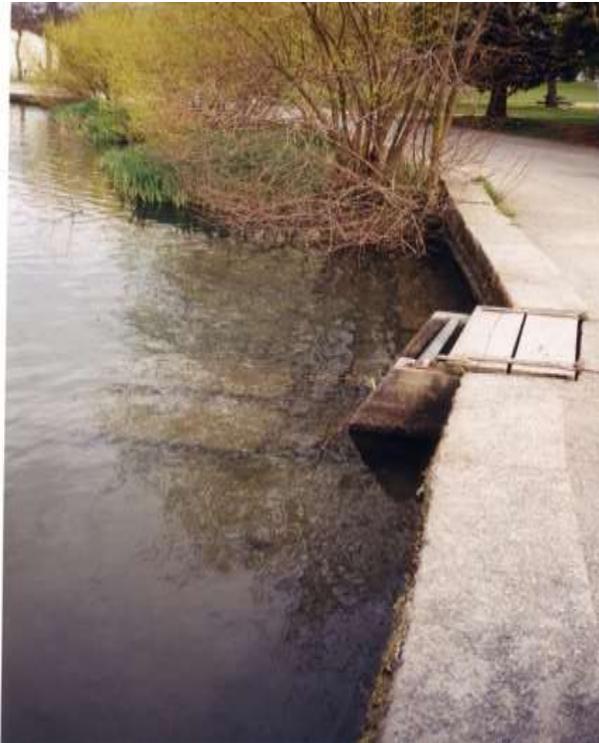
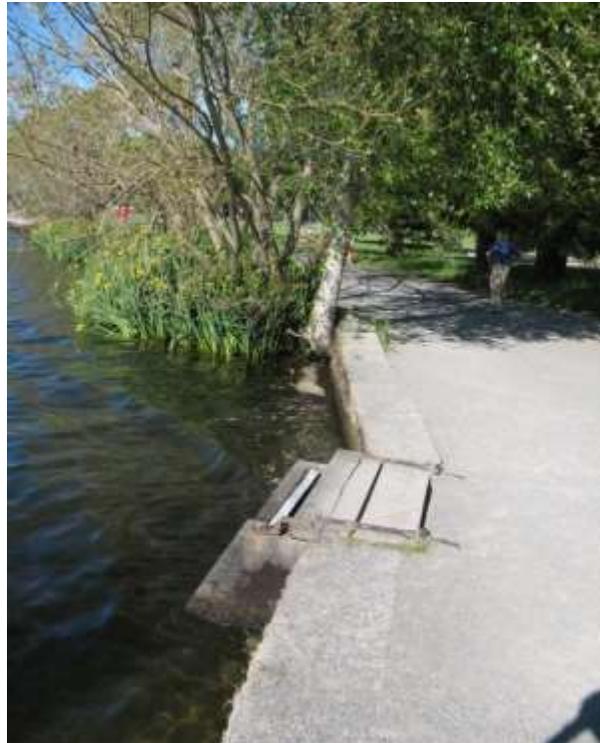
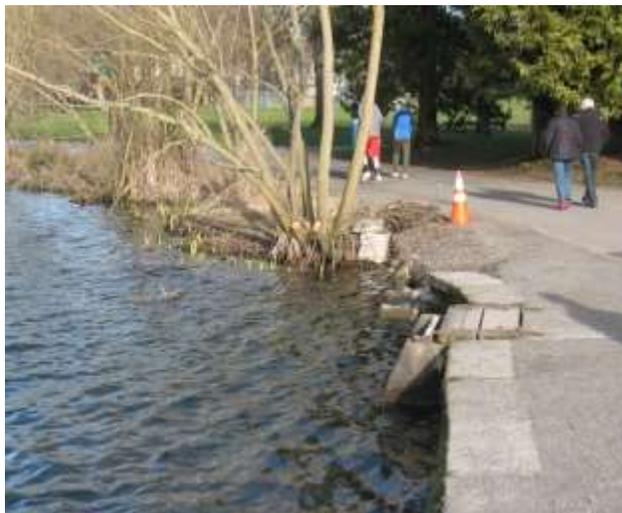
2004: Trees & Shrubs at Sunnyside Outlet

2014: Trees & Shrubs at the Sunnyside Outlet

2015: Shoreline wall has toppled at the Sunnyside Outlet

In order to repair the wall an Hydraulic Permit was required. The permit process provides for the Washington Department of Fish and Wildlife to review and condition the permit with appropriate mitigation measures to compensate for loss of fish and wildlife habitat. Mitigation for the wall repairs was undertaken at a site near the Wading Pool. A portion of the shoreline was enhanced with new plantings, placement of large rocks and logs, and a fence to protect the plantings. Shoreline access for hand carried water craft was also included at the mitigation site.

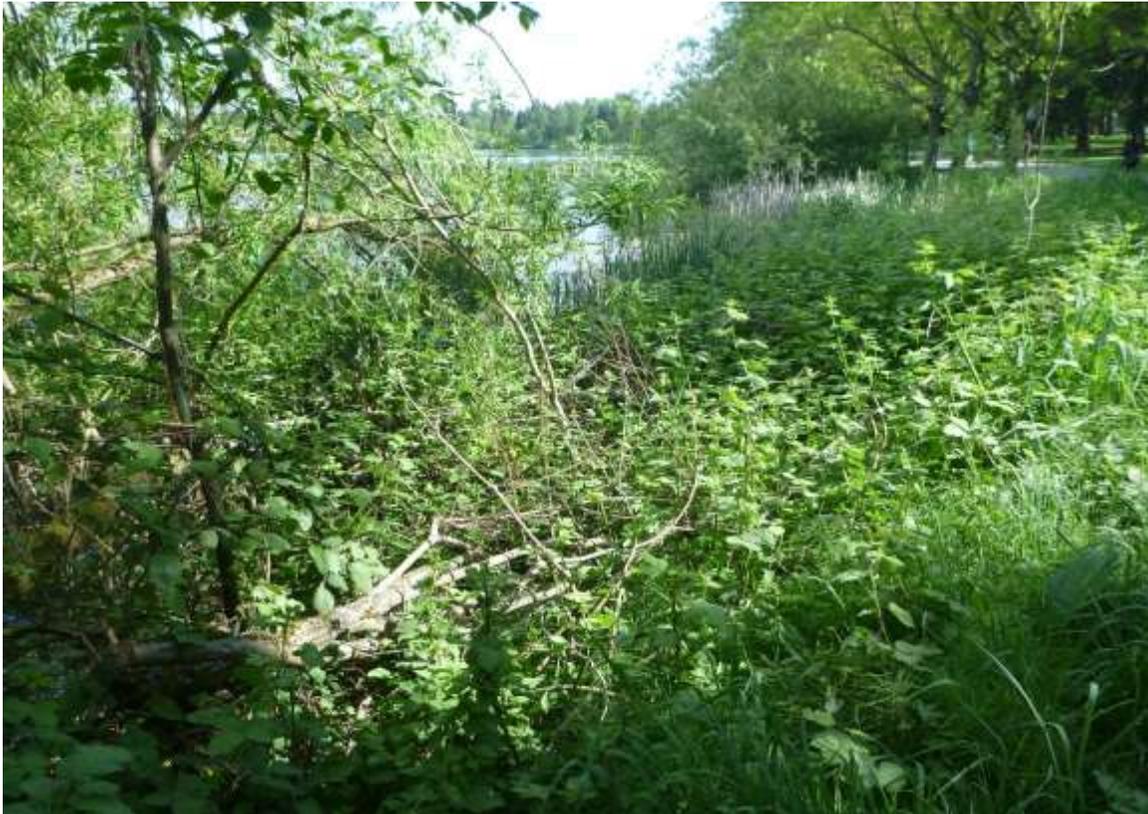
Tree branches lying on riparian vegetation. The branches are now submerged in blackberry.

Problem: Nesting habitat for red-winged blackbirds has been lost because willow branches overhanging the shoreline were pruned during the winter of 2015/16 and the branches were allowed to drop onto the riparian vegetation. The pruned branches were not removed at the time. The dropped branches provided a scaffold on which the blackberry quickly grew, shading out the cattails

Recommended Action: Volunteers or SDPR remove branches and blackberry vines for SDPR removal.

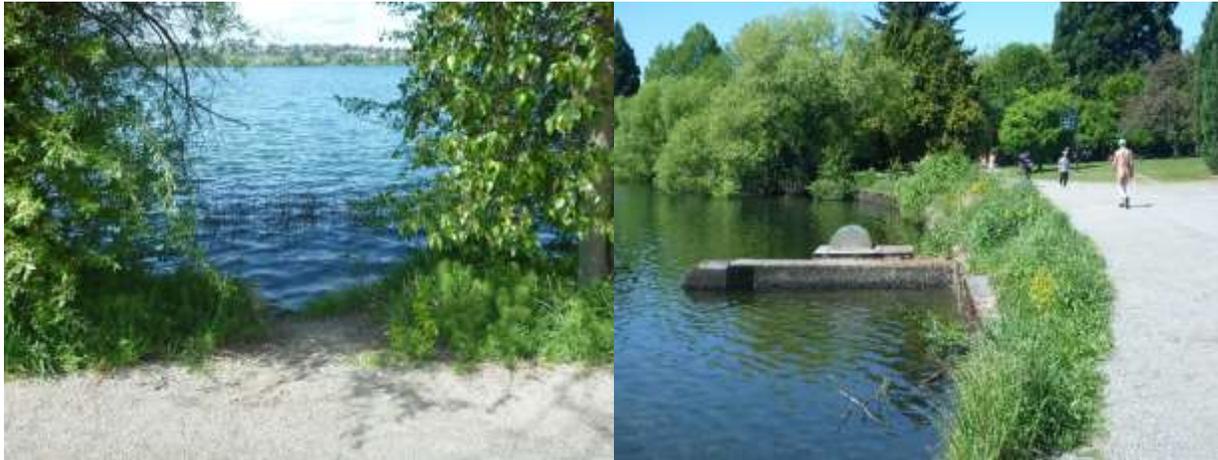
Gravel moving toward lake.

Location: The Green Lake Path was designed as an eight foot wide asphalt path with an additional four feet of gravel path on the lake side of the path. Since the trail was rebuilt in 1997, the gravel trail has been widened both by use and by subsequent addition of gravel to the trail.

Problem: While the widening trail facilitates the increased use of the Green Lake path by park users, it would be appropriate to impose a limit on its widening. In many locations, the gravel portion of the path now extends to the topographic break between the flat trail area and the slope to the shoreline of the lake, and gravel is now working its way downslope into the lake. Surface water runoff carries silt and associated nutrients into the shoreline waters.

Recommended Action: A "curb" treatment is needed to limit the shoreward creep of the gravel portion of the path. The treatment should permit the movement of water from the trail towards the shoreline and filter the water that passes through. The "curb" should stop the creep of the gravel portion of the path towards the lake.

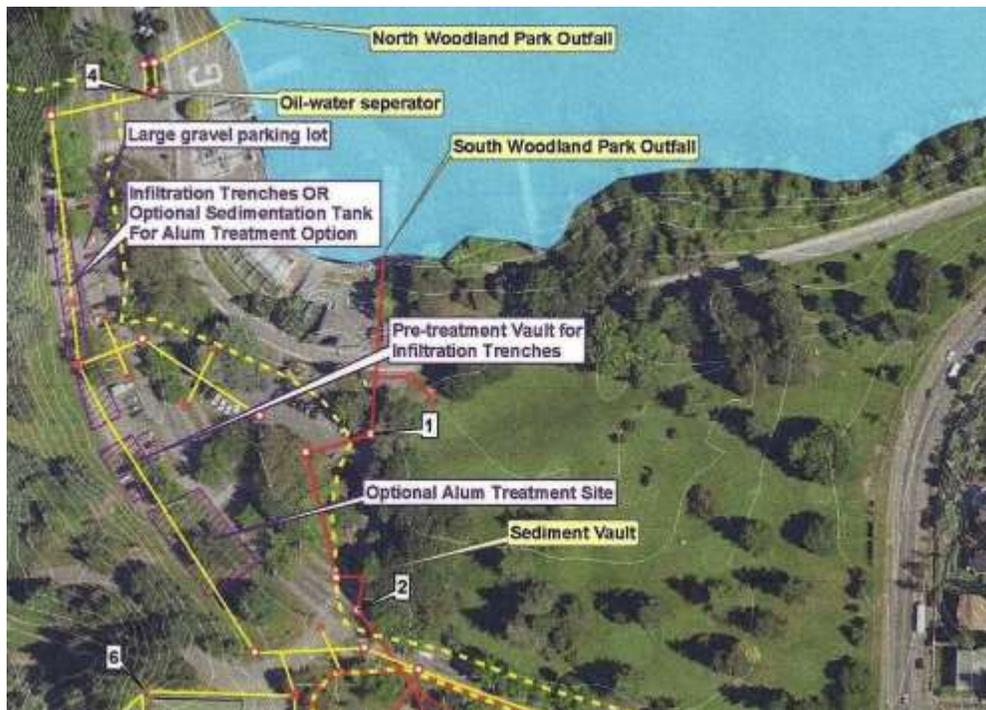
A complex of treatment vaults, oil and water separators and aggregate trenches treat runoff coming from Lower Woodland Park playing fields and other facilities.

Problem: Surface water runoff from the playing fields, tennis courts, roads and parking areas in Lower Woodland Park is collected in a drainage system that sends the runoff through treatment vaults located under the Small Craft Center parking lots before the runoff water enters Green Lake. Functioning correctly, the vaults remove oil and silt from the runoff water.

Recommended Action: Open and inspect the vaults. Clean and treat as appropriate.

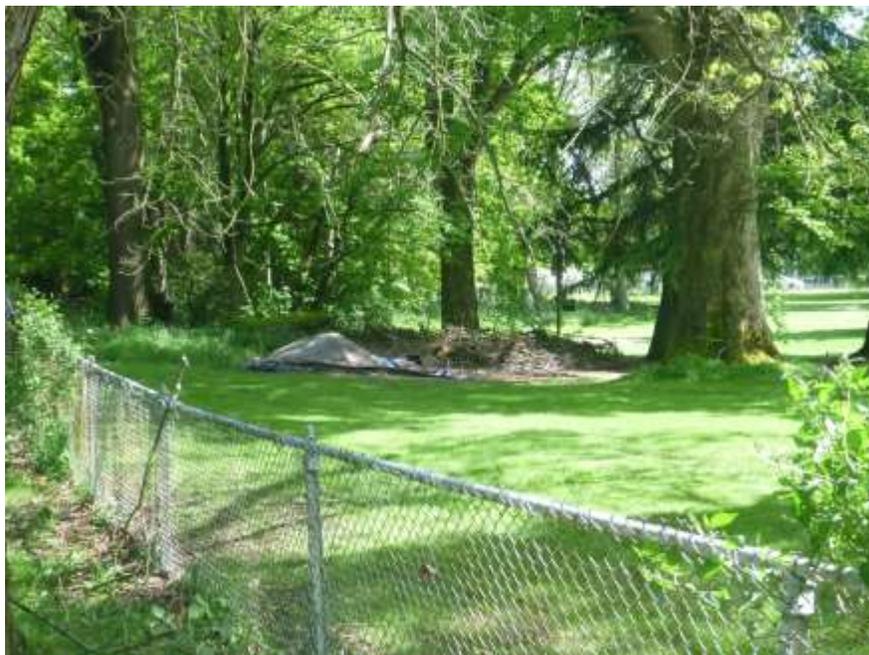
Debris piles in the Pitch and Putt Golf Course persisting over the winter.

Problem: Tree trimming and other maintenance debris has been stored under the trees at the northeastern end of the course.

Recommended Action: Remove the debris piles.

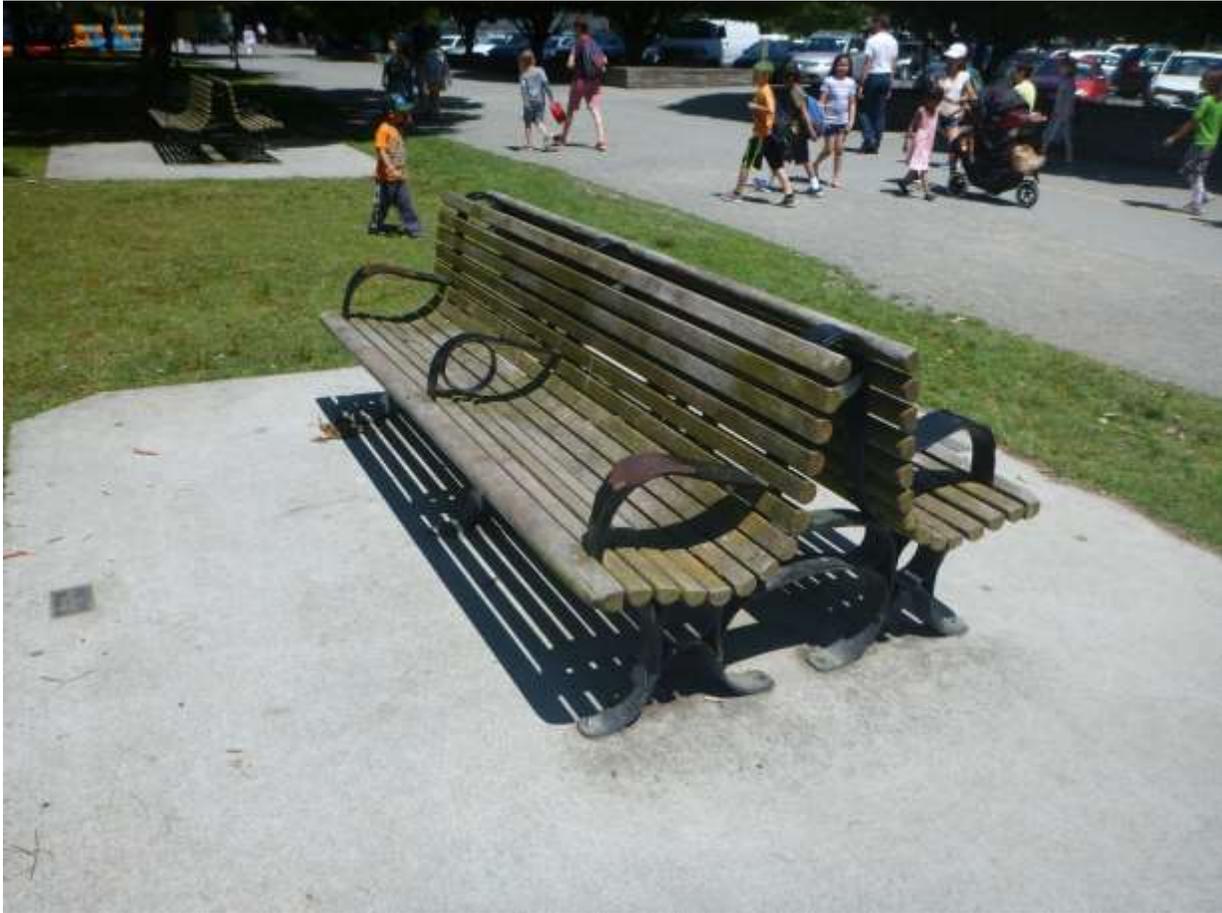
Double-sided Bench at East Beach

Problem: The finish has weathered off portions of the benches.

Recommended Action: Inspect the benches in Green Lake Park and refinish as necessary.

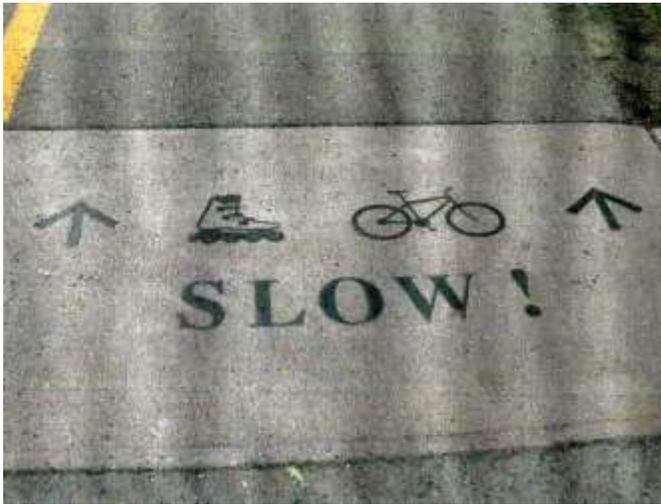
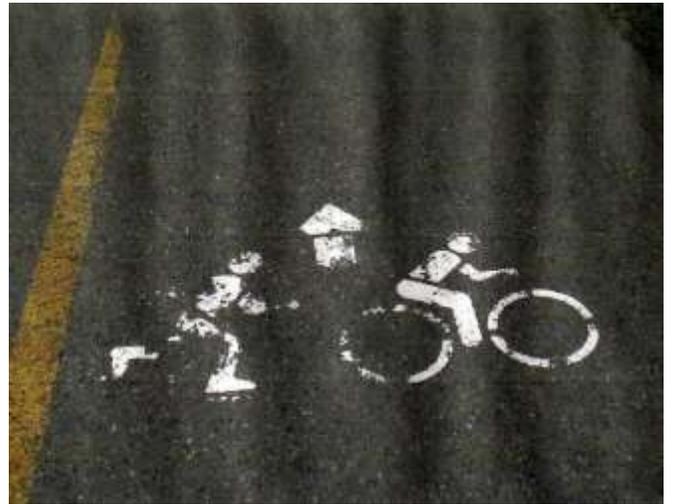
Embedded Brass Signage

Stenciled Signage

Problem: Green Lake Path is often congested and there are conflicting activities including walkers, joggers, strollers with toddlers, skateboards, and racing bicycles. While there are many solo users, frequently the users are in small groups. Thus, moving blocks of people often form. One effort to reduce conflict between uses is to have “wheels” (bicycles and skaters) go counter clockwise on the street side of the path around Green Lake and to have walkers go on the lake side of the path in either direction. The traffic signs need to be readily visible and with a clear intent. The embedded brass signs achieve this goal though there are not many of these signs. The stenciled signs are more visible when new but rapidly degrade and do not have the important “**SLOW**” warning.

Recommended Action: Repaint the stenciled signs more frequently and include “**SLOW**”. With current levels of use on weekends, it may be appropriate to eliminate bicycles on the path on Saturday and Sunday from 9:00 AM to 4:00 PM. The City has made a great effort to provide bicycle lanes on streets, including Green Lake Way. Thus, on weekends, it may be appropriate to shift bicycles from the Green Lake Path to the bicycle path on Green Lake Way.

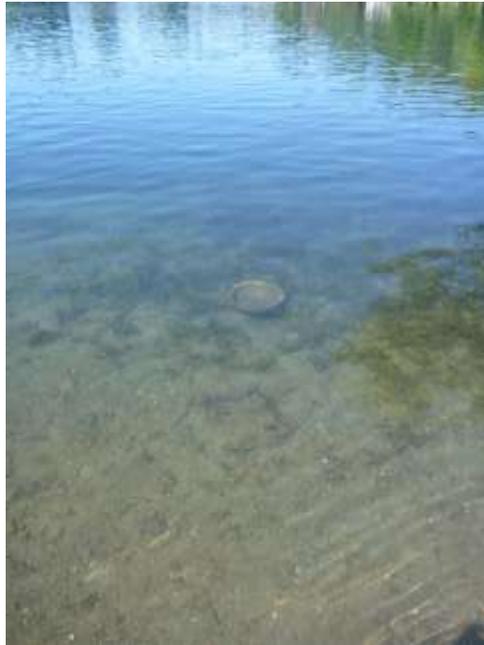
Waste Bin Lid Near Sunnyside Outlet

Problem: Various kinds of debris are in the shallow, nearshore waters of Green Lake. In addition, woody debris is present in the wetland areas of Green Lake. It is FOGL's understanding that this material is not removed by grounds keepers because their labor contracts preclude entering the water. SDPR should not be dependent upon volunteers to perform tasks in shallow water near the shoreline.

Recommended Action: At least some SDPR personnel should be enabled to undertake tasks in the shallow waters along shorelines and in wetlands.
